Technical Bulletin
Concrete Roof Tile Surface Marks

ISSUED: OCTOBER 15, 2026

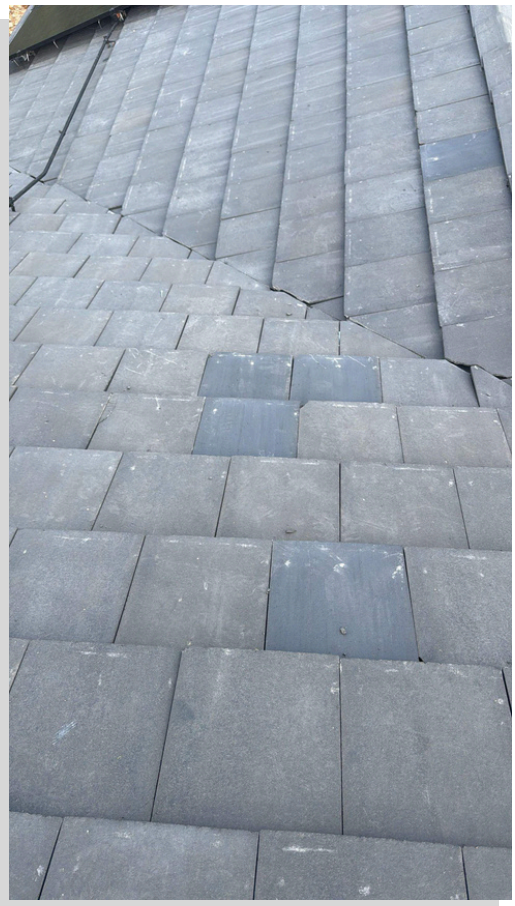
Occurrence During Shipping and Handling

Scuff marks may appear on concrete roof tiles during shipping and handling. These marks are typically caused by **minor disturbances to the factory-applied sealer.**

These scuff marks are **temporary and will fade** as the sealer weathers over time.

The presence of scuff marks **does not affect the color of the tiles or their structural integrity.**
